Sigtronics Panel Mount Intercom Sidetone Modification

Intercom Models: **Sport 200** Circuit Board 1528 S/N 6202993 - to - Current
SPA-400* Circuit Board 1528 S/N 6069006 - to - Current
SPA-600* Circuit Board 1528 S/N 1102528 - to - Current
SDB-800 Circuit Board 1528 S/N 1151486 A & B - to - Current

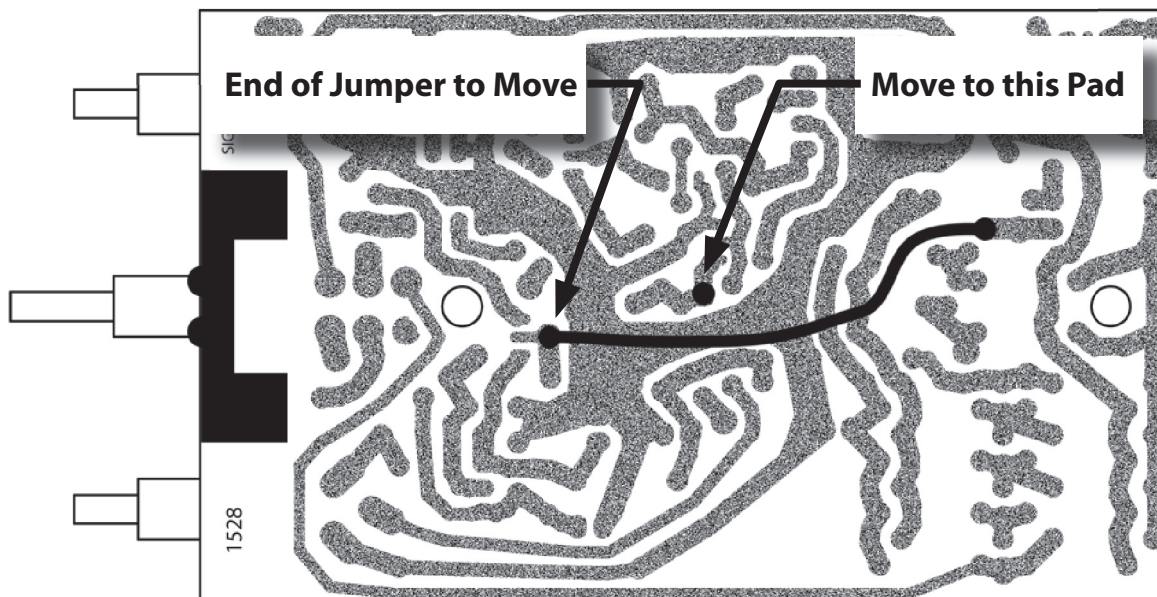
Most aircraft radios, when transmitting, provide what is called "side-tone". Without side-tone, you will not hear yourself or your co-pilot transmit to ATC. This can be distracting, especially during instruction, because no one on the intercom will hear the outgoing transmission side of the radio conversation. Some aircraft radios do not provide this function, other radios are designed to drive only one headset. Therefore, if you have such a radio, the side-tone may be extremely weak or non-existent. If this is the case and the side-tone is absent or cannot be turned up in the radio(s), a simple modification can be performed within the intercom to simulate side-tone.

To complete the circuit board modification, remove the three screws securing the bottom cover to the case and carefully lift the cover from the case. Locate the jumper wire (usually brown in color) on the solder side of the circuit board. Note that the circuit board does not need to be removed from its case to complete the "side-tone" modification. Unsolder the wire from the solder trace at the end closest to the controls. Move the free end of the wire to the solder pad indicated in the attached drawing and solder the wire to the trace at the location specified.

To accomplish this modification the unit must be removed from the aircraft. This is done by first removing the volume and squelch control knobs with an 0.05 inch Allen wrench. Then remove the two mounting screws and switch nut which hold the unit in the instrument panel. The unit is now free for removal from the aircraft after disconnecting the cable at the plug.

Replace the cover and secure it with the three screws as before. Install the unit back in the instrument panel as before and plug the cable back together.

NOTE: With the unit modified in this way, the intercom volume control adjusts the level of the side-tone.
